# THE CONSERVATOR'S SCRUTINOUS EYE – SCIENCE IN THE SERVICE OF ART

The interiors of the Imperial Castle in Poznań are embellished with scores of different stone varieties. In order to preserve and renovate them, an in-depth conservation examination needed to be performed.

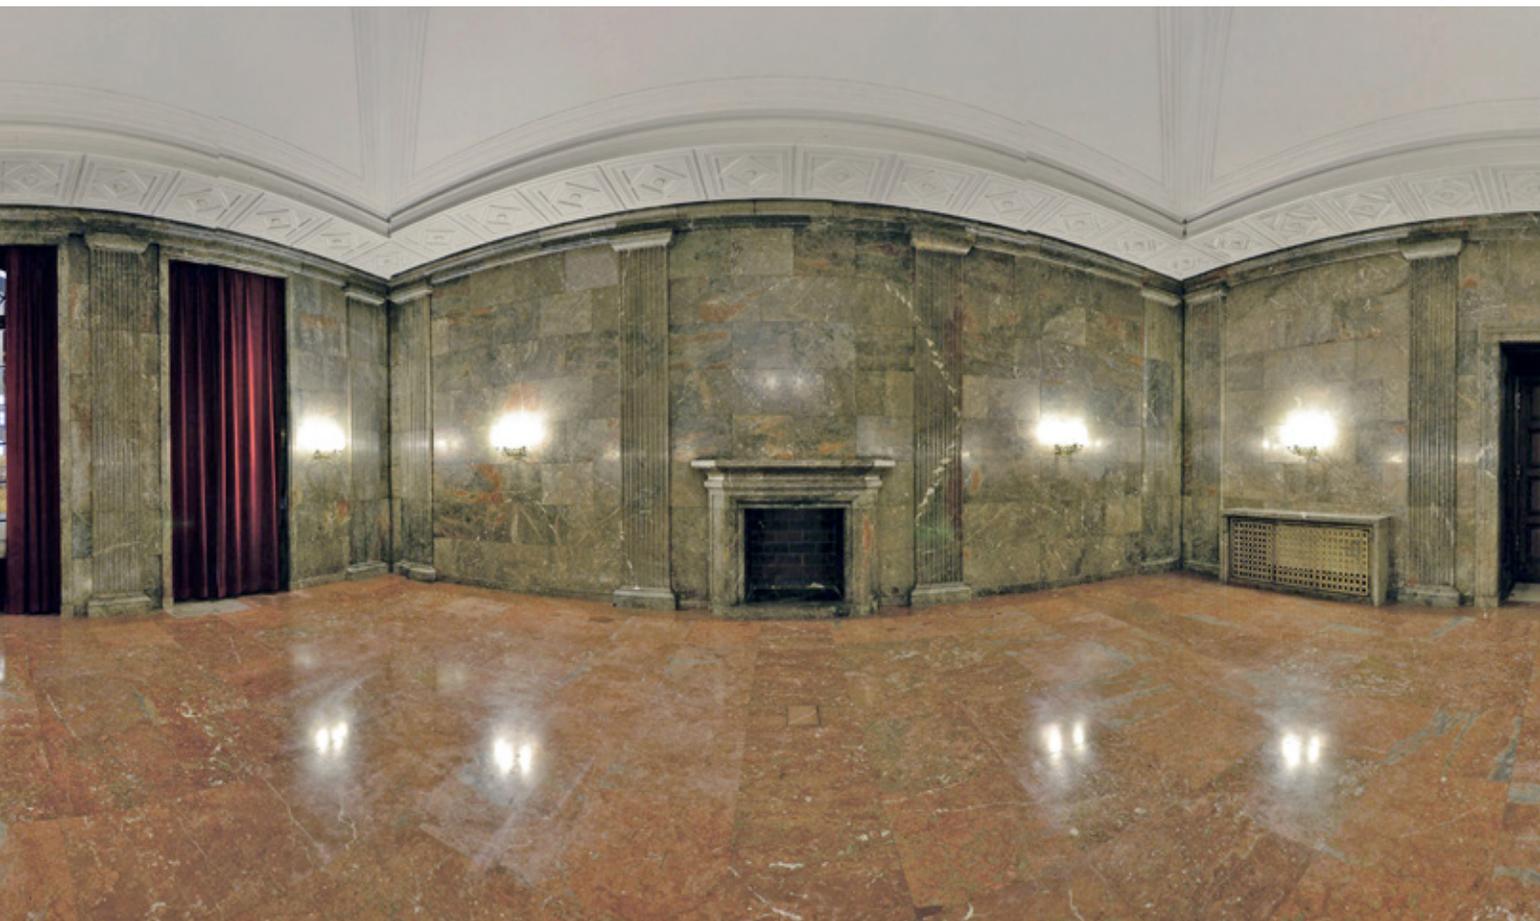
The Führer's cabinet on the first floor (a panorama compiled of several photos). The room's colors, the red-brown flooring and the green walls, are particularly striking

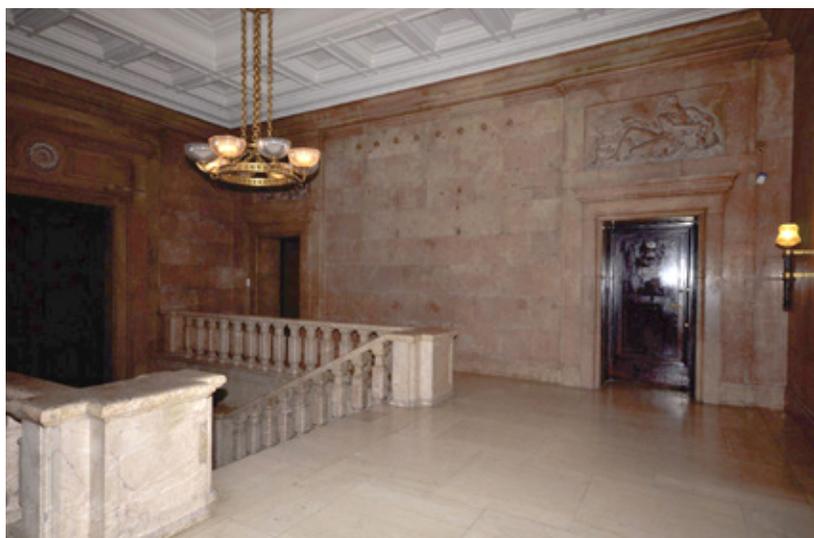
The grand stairway opening up from a vast hallway. All the original decorative elements and fittings are easily visible here: stone cladding, reliefs, coffered ceiling and massive, brass lamp holders

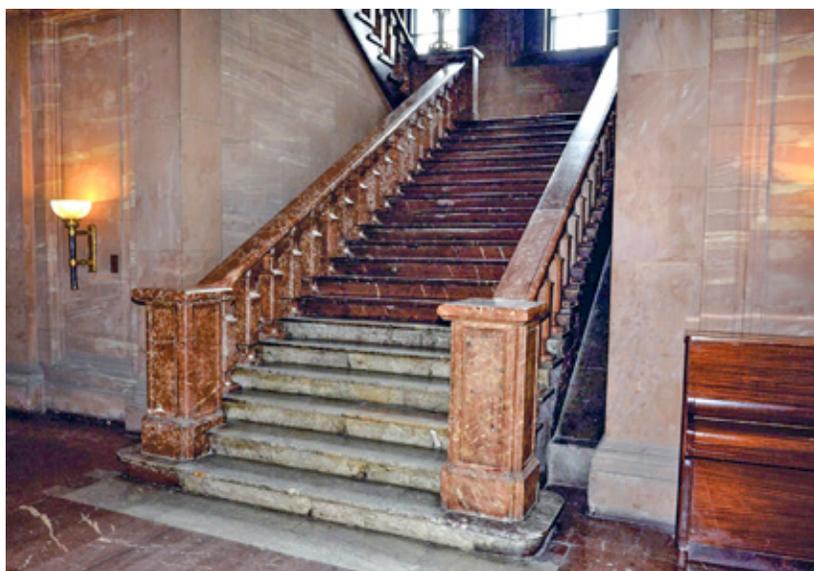
The second grand stairway was heavily damaged. During the conservation works after WWII, some elements such as handrails were restored. Given the lack of original stone, the scagliola technique (i.e. plaster imitation of stone) was used. The result of the work and its quality command admiration

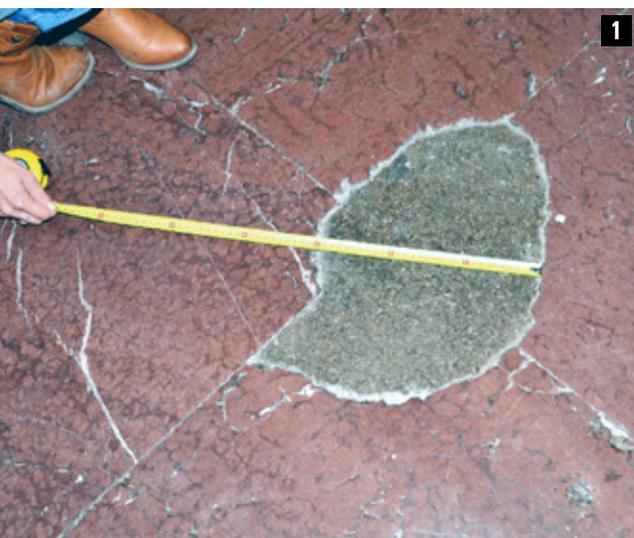
Photo 1  
Damaged portion of limestone flooring which had been filled in with cement. During the conservation work, the concrete had to be removed and the stone had to be replaced, using material from the identified quarry – in this particular case, micritic limestone Ammonitico Rosso from Italy

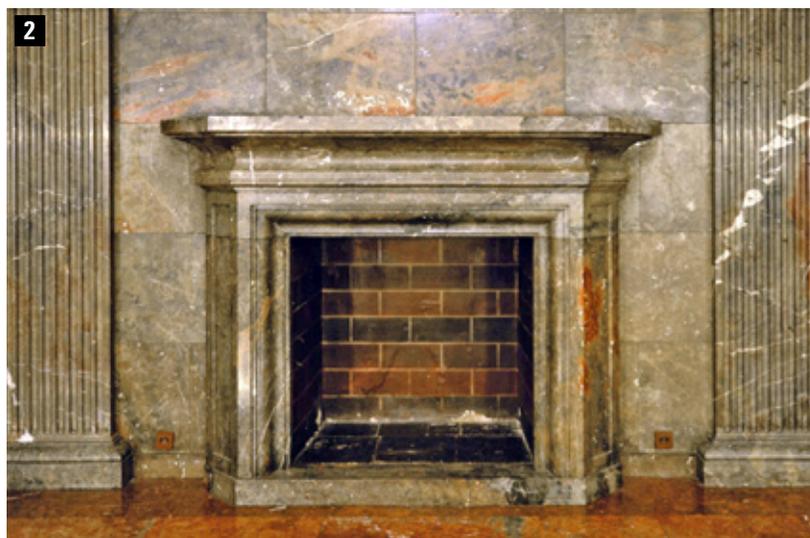
Photo 2  
One of many fireplaces in the Imperial Castle in Poznań. The gorgeous texture of organodetrictic limestone Auberg Grau from a German quarry is well visible
