## Correction of Acoustics in Historic Opera Theatres with the Use of Schroeder Diffuser

Tadeusz KAMISIŃSKI

*AGH University of Science and Technology*

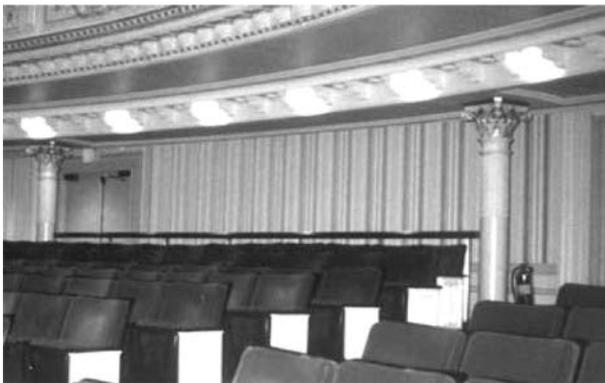
An example of the use of Schroeder diffuser in a concert interior of historic interest is the Carnegie Hall in New York (Fig. 2). On the rear flat wall, the diffuser was installed in order to reduce echo heard on the stage (COX, D'ANTONIO, 2003).

Fig. 2. Schroeder diffusers (QRDs) applied to the rear wall of Carnegie Hall to prevent echoes.

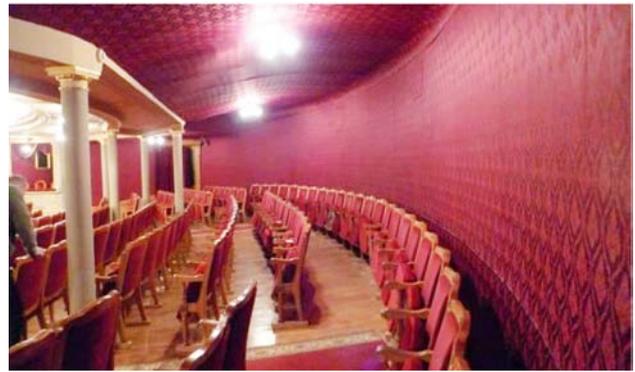
Figure 3 shows a view of the underbalcony space in the Lviv Opera House hall before installation of diffusion panels. In this case, it has been decided that the diffuser would be installed on a semicircular wall which would allow to test the function of the structure in different geometrical situations.

Fig. 3. A view of semicircular underbalcony space in Lviv Opera House before installation of diffusion panels.

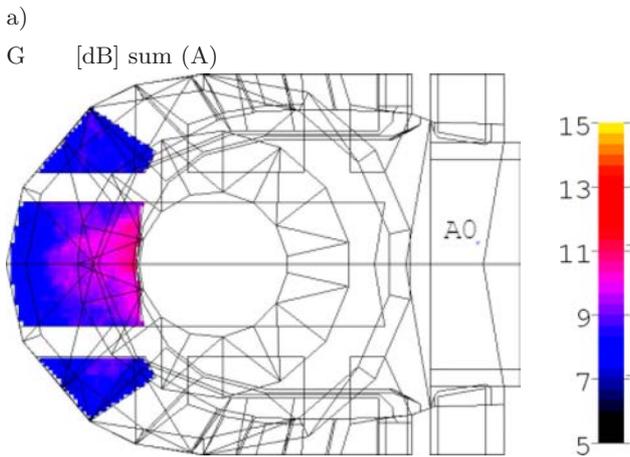
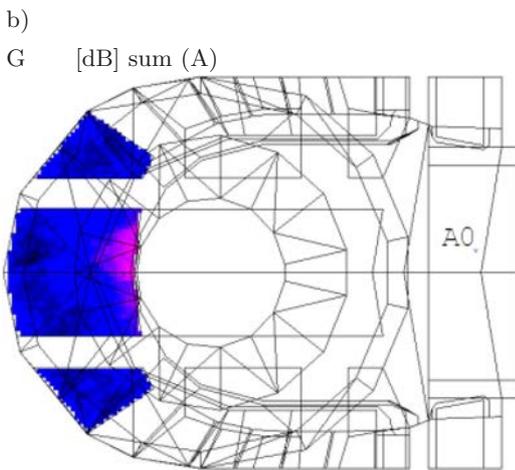
Results of both simulations are presented in Figs. 4a and 4b. To illustrate the effect of the planned adaptation, the parameter known as the sound strength  $G$  was selected, defined by means of formula (KULOWSKI, 2011):

Fig. 4. The forecasted distribution of  $G$  values under the balcony in the hall's stalls: a) wall with tapestry; b) wall with the diffuser.

hall centre a decrease of value of the indicator occurred after installation of the diffuser in the underbalcony cavity, but distribution of the parameter has clearly gained in evenness as a result of occurrence of diffused reflections. Based on the observation one can conclude that introduction of sound diffusing element onto the rear wall will cause reduction of the sound focusing phenomena in this area and have a positive effect on audition qualities. Much better results should be expected when observing the simulated parameters for frequencies above 1 kHz, as in this very range the sound absorption is being reduced, and diffusion increased (Fig. 4). When interpreting the plots, one should also bear in mind the limitations of the ray method used by CATT-Acoustic program.

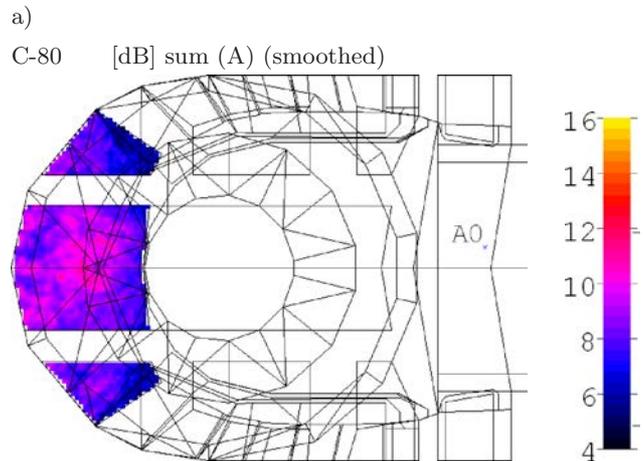
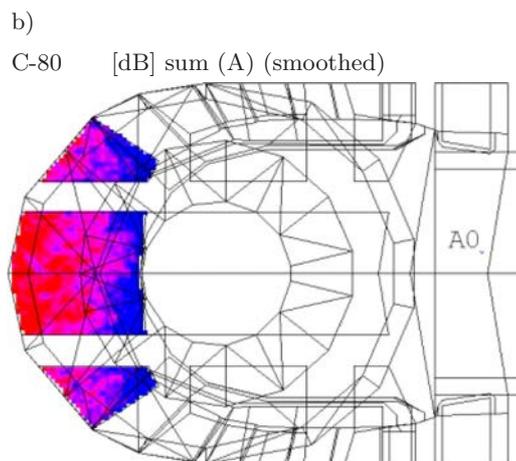
Figure 5 shows the forecasted distribution of  $C_{80}$  parameter under the balcony on the hall's stalls for: (a) the back wall with textile tapestry; (b) the same wall with Schroeder diffuser. The parameter, known

Analysis of simulation shows (Fig. 5) that the use of the diffuser will result in an increase of the sound clarity  $C_{80}$  in last rows of the stalls.

Fig. 5. Forecasted distribution of  $C_{80}$  values under the balcony in the hall's stalls: a) wall with tapestry; b) wall with the diffuser.

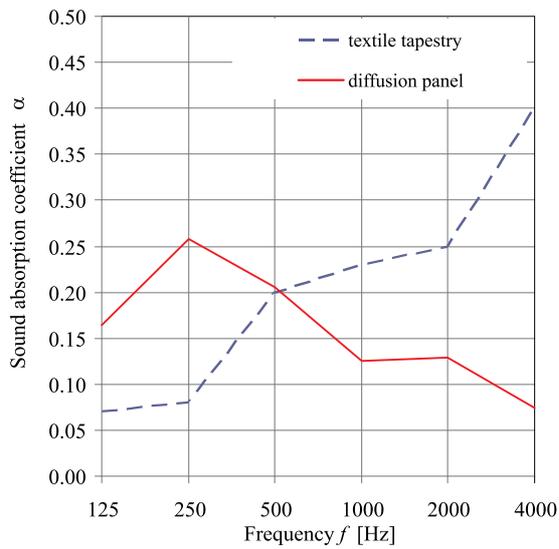
Figure 6 shows the comparison of sound absorption coefficient values for textile tapestry and the diffusion panel.

Fig. 6. Comparison of sound absorption coefficient values for textile tapestry and the diffusion panel.

tively diffuses the sound. Analysing absorption characteristics of the textile tapestry and the diffusing structure (Fig. 6) it can be found that below the frequency of 1 kHz, the diffuser is characterised with the sound absorption coefficient higher than this of the tapestry. As a result, after installation of the diffuser, a portion of energy is absorbed and does not come back to the auditorium. Above 1 kHz, sound diffusion starts to manifest itself with low absorption, giving the acoustic energy back to the hall in a way ensuring its uniform distribution. The phenomenon has been confirmed by means of analogous observation of the parameter  $G_{4\text{kHz}}$  that more clearly depicts the effect of the diffuser on the hall's acoustic field.

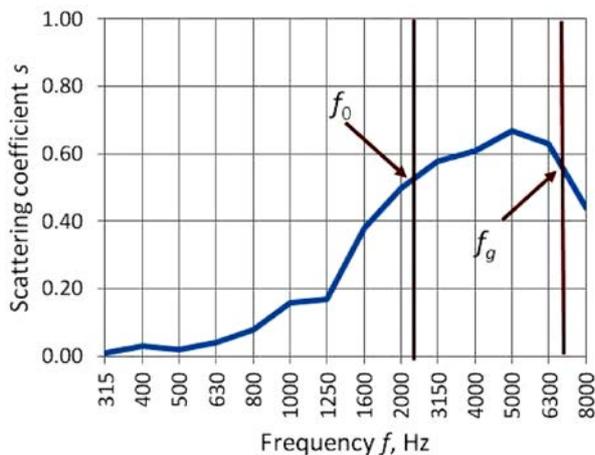
Fig. 8. The sound scattering coefficient  $s$  of the diffusion panel determined according to ISO 17497-1 (2004).

In Fig. 8, the lower  $f_0$  and the upper  $f_g$  limit frequencies for sound diffusing effect of the examined structure are marked. It is assumed that the structure has the capacity to redirect the sound starting from frequency equalling  $0.5 f_0$  (COX, D'ANTONIO,

2004). The design frequency  $f_0$  is determined by the maximum depth of the diffuser. In the Opera House there was a very limited space designed for the diffuser, therefore it was very difficult to lower  $f_0$ . What is more, as indicated by (PILCH, KAMISIŃSKI, 2011), the higher deep-to-width ratio of one well of diffuser, the bigger sound absorption of the entire structure in low and mid frequency range. Consequently it was impossible to increase the range of effective diffusion of panels without interference with the reverberation time of the hall.

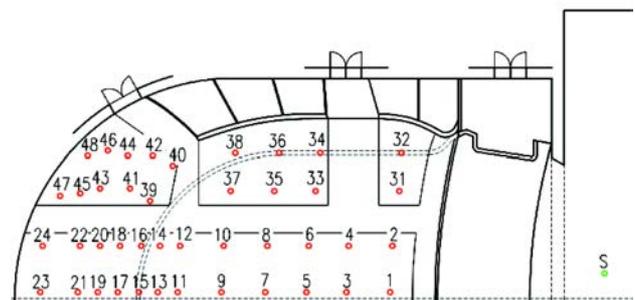
Repeated examination of the Opera House hall's acoustic parameters carried out, according to the pre-determined methodology, before and after installation of the structure on the rear wall, was used for verification of the implemented system. To increase precision of the analysis of acoustic phenomena occurring in locations where main changes were forecasted, the grid of measurement points has been condensed in the area under the balcony in the centre of the Opera's stalls (Fig. 9).

Fig. 9. Distribution of measurement points in the hall's stalls.

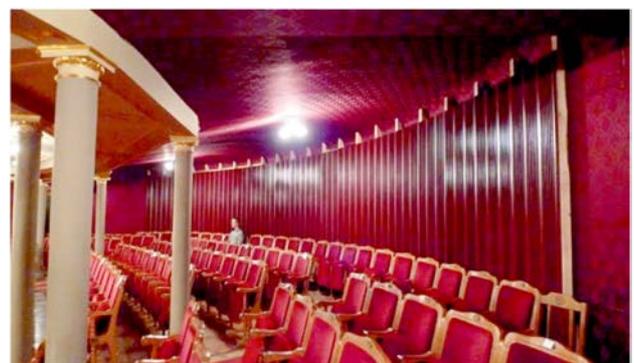
Figure 10 shows a view of semicircular back wall of the underbalcony space in the Lviv Opera House after installation of diffusion panels in the course of verification measurements.

Fig. 10. A view of the semicircular back wall behind the underbalcony space in the Lviv Opera House after installation of diffusion panels.

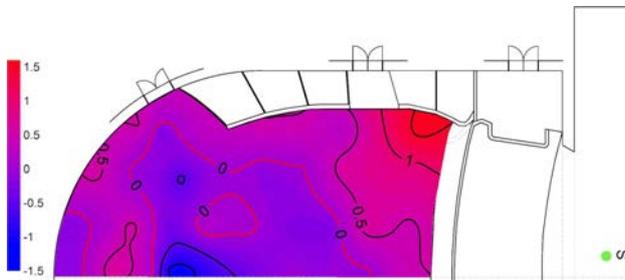
A comprehensive review of the measured acoustic parameters of the hall revealed that the parameters showing the highest sensitivity to introduction of the structure were the sound strength factors  $G_{\text{mid}}$  and  $G_{4\text{kHz}}$ . The following Figs. 11 and 12 show distribution of the parameters on the auditorium's stalls surface.

Fig. 11. Distribution of the sound strength  $G_{\text{mid}}$  increase after installation of the diffuser.

After application of the diffuser on the rear wall, one can observe a slight increase of value of the sound strength factor  $G_{\text{mid}}$  in the underbalcony area, while in the central part of the hall, values of the parameter have been reduced.

The analysis of acoustic parameters of the Lviv Opera House hall measured before and after installation of the diffuser has shown that the best parameters allowing for observation of the discussed structure's effect were the sound strength values  $G_{\text{mid}}$  and  $G_{4\text{kHz}}$ . To this end, interpolated distributions of measured values of the parameters over the stalls area were worked out. Parameters  $G_{\text{mid}}$  and  $G_{4\text{kHz}}$  are presented in the form of difference of values observed before and after installation of the diffuser (Figs. 11 and 12).

According to the generally observed regularity, value of the sound strength factor  $G_{\text{mid}}$  decreases with increasing distance to the sound source. On the other hand, in the central part of the hall, some increase of the parameter values can be observed caused by sound focusing effect of the back wall's concave surface. After installation of the diffusing structure, the effect has been reduced, as confirmed by the measured values of the sound strength factor and the distribution of increase in  $G_{\text{mid}}$  (Fig. 11). The observed change occurs for frequencies 500 and 1 kHz, i.e. below the frequency for which the designed diffusion panel effec-

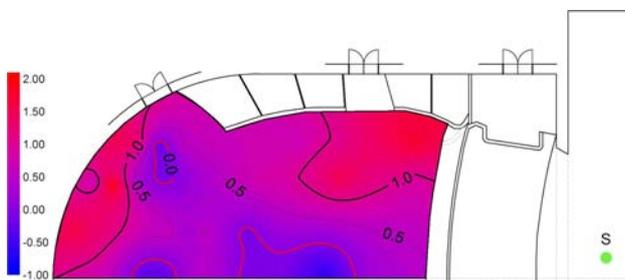
Fig. 12. Distribution of the sound strength factor  $G_{4\text{kHz}}$  increase after installation of the diffuser.

Values of the  $G_{4\text{kHz}}$  parameter, as shown in the figure above, are subject to distinct decrease in the central part of the hall, and locally increased as a result of providing the semicircular wall with the diffuser.

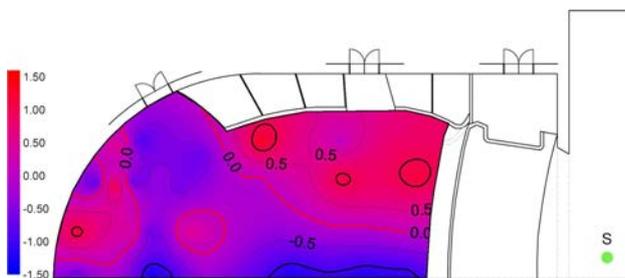
Analysis of the sound clarity index  $C_{80}$  for the 4 kHz has revealed (Fig. 13) that as a result of installation of the diffuser, values of the parameter significantly decreased on the hall's axis.

Fig. 13. Distribution of the sound clarity index  $C_{80}$  4kHz increase after installation of the diffuser.

The performed research work revealed that significant changes in acoustic parameters occur for early reflections of waves incoming within the time interval of 80 ms, as can be seen from distribution of parameters  $G_{80}$  and  $C_{80}$  (Fig. 13). Its effect in later instants of time is not noticeable, as can be found based on analysis of the factor  $G_L$  (Fig. 14b).

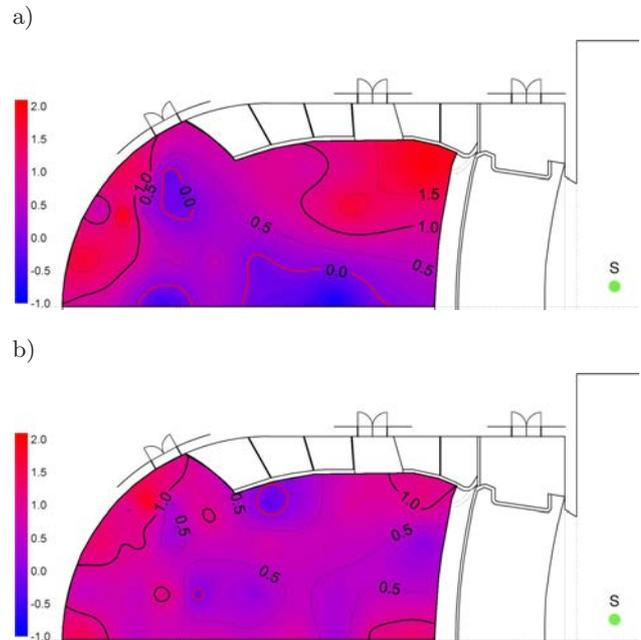
$G_{80}$  4kHz (the early sound strength) and  $G_{L}$  4kHz (the late sound strength) for 4 kHz were also investigated. On the basis of measurement before and after installation of the diffuser (Fig. 14), it can be said that the sound strength is changed mainly in the early part, as  $G_{80}$  4kHz is very similar to  $G_{4\text{kHz}}$ .  $G_{L}$  4kHz distribution is very regular and reveals an about 0.7 dB increase for the whole stalls surface.

Fig. 14. Distribution of differences of sound strength factors: a)  $G_{80}$  4kHz and b)  $G_{L}$  4kHz.
